MENLOUGH CASTLE
GALWAY CITY

CMF23-1-GC001

Final Report

NOVEMBER 2023

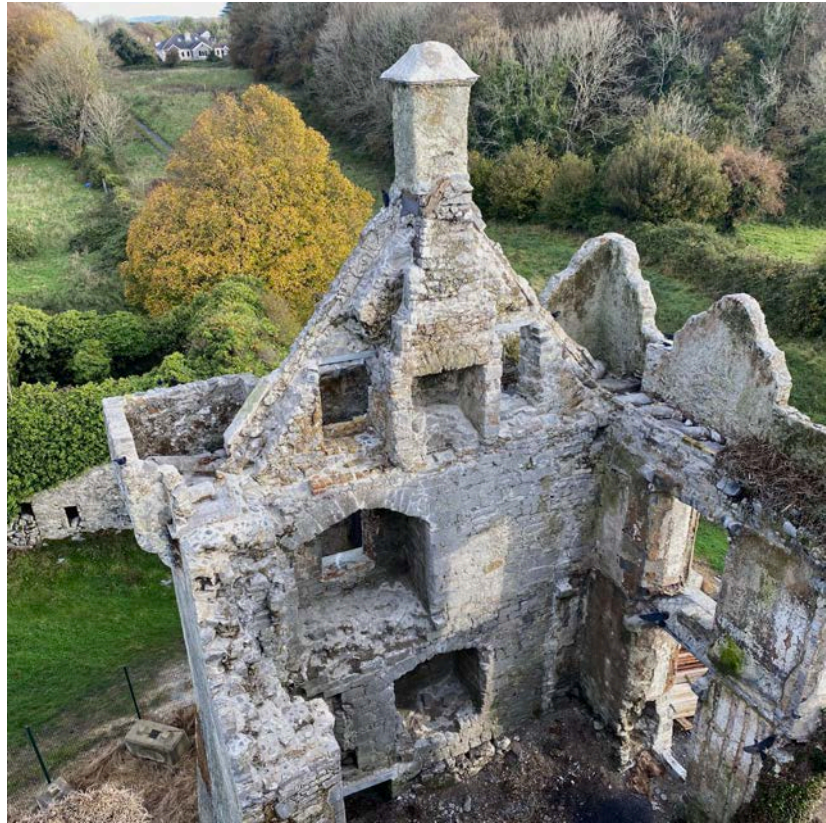
In 2022, the existing contract was extended to address the structural stability of the former tower house to the north end, along with the junctions with the east and west ranges. The west shoulder had fallen close to first floor height, so that there was little support in this corner. On the opposite side, a long crack was repaired using stainless steel sock anchors from ground to high level where the two phases were at risk of separating over time.

At high level, the wall tops were relatively sound, and the drainage stones along the parapet were found to be very well preserved. Openings to the walls and flues were at risk of collapse and were strengthened to ensure their stability. Some additional salvaged stone was added to ensure that the lintels over the surviving openings were properly loaded and stable. Fortunately, much of the external render has survived, so that there was little repointing required to these surfaces. Repointing was required to the internal wall surface to strengthen walls where mortar has washed out over time. Brickwork to the bartizan was found to be in fair condition, and it was decided not to proceed with a lime shelter coat.

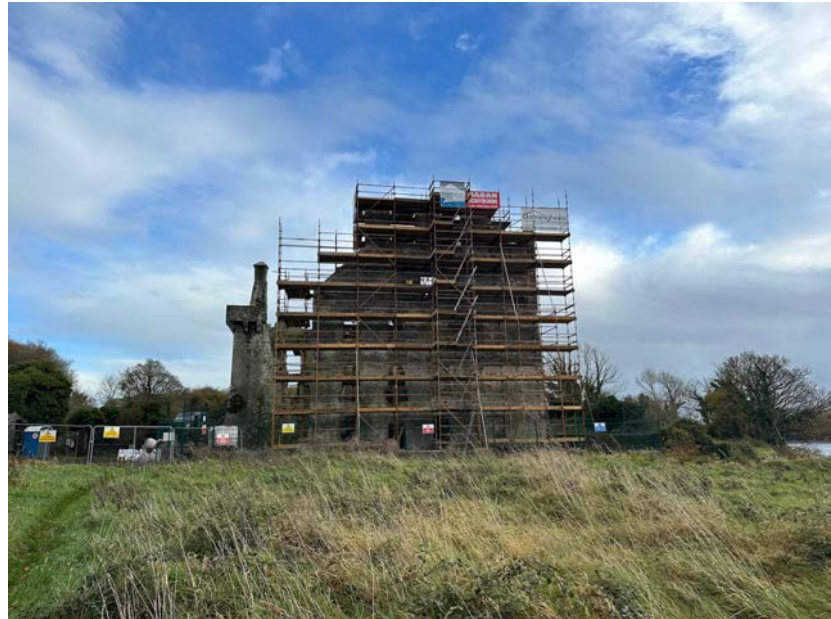
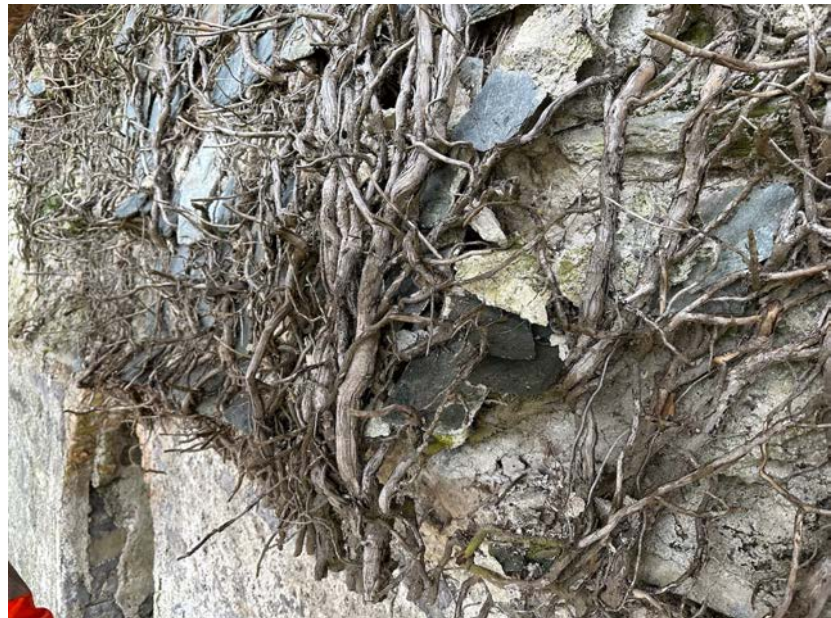
At the spine wall, the works were confined to the east side to minimise disturbance of the summer roost of the long-eared bat. Of most concern in this location was the loss of the structural support to the belvedere, the small stone room set at parapet level. The cut stone arch that supported its west wall has lost its bearing end, so was at immediate risk of collapse. A new stone corbel carved by Galway Stone Design was installed to support this arch without the necessity of it being taken down, or using permanent steelwork. Adjacent pinnacles, chimneys and wall tops were choked with ivy and were cappings were re-seated where loose and open joints repointed. Due to additional funding we were able to repair some adjacent areas to the south and west walls at high level.

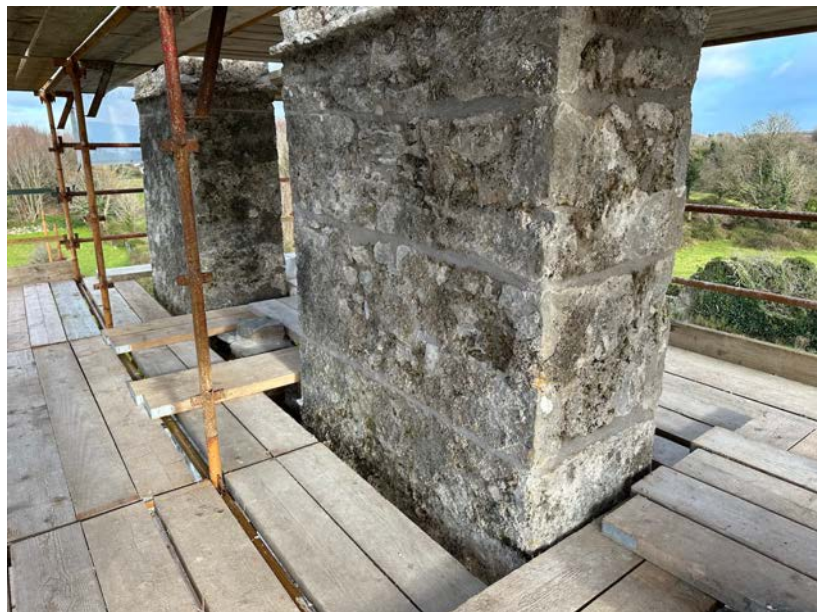
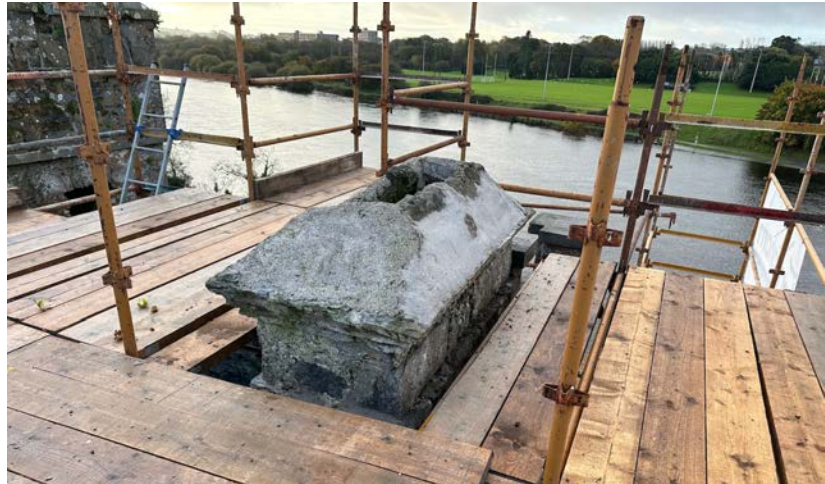
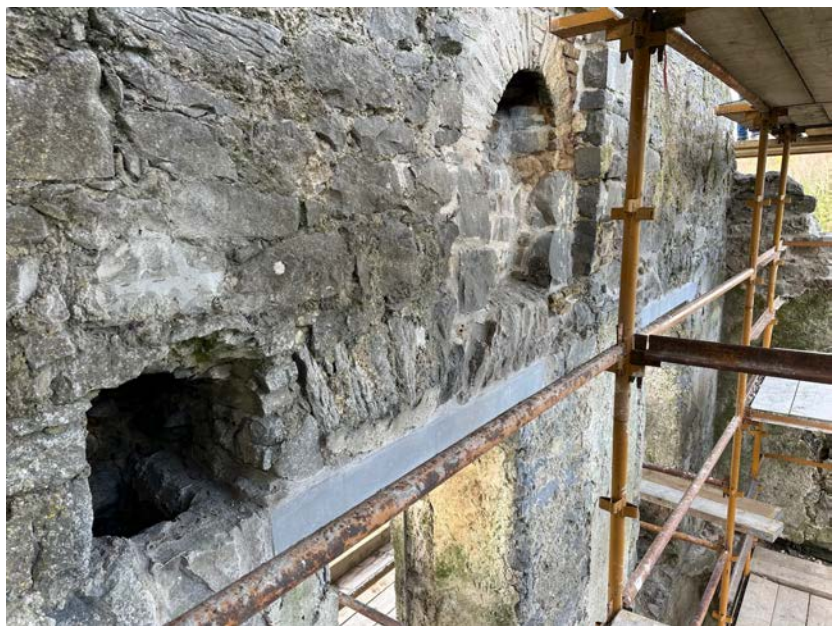
Enlarged openings were strengthened with new lintels and jambs where necessary, and damaged or cracked lintels repaired. Large cracks to the chimneys were stitched with stainless steel ties, retrofitting to those installed in the last phase. The distinctive slate wall coverings to the upper levels were checked for loose slates and were re-bedded in quicklime mortar after raking out loose or

unsuitable bedding to ensure good adhesion. Sound slates were left in place. Works will proceed so as not to disturb nesting birds or their nests. During this phase, suitable stone was retrieved from piles in the east range under archaeological supervision where it fell following the fire in 1910, for use in the consolidation of the openings and pinnacles. Unfortunately, very little stone cappings for the pinnacles were identified, perhaps having been taken off site following the fire.

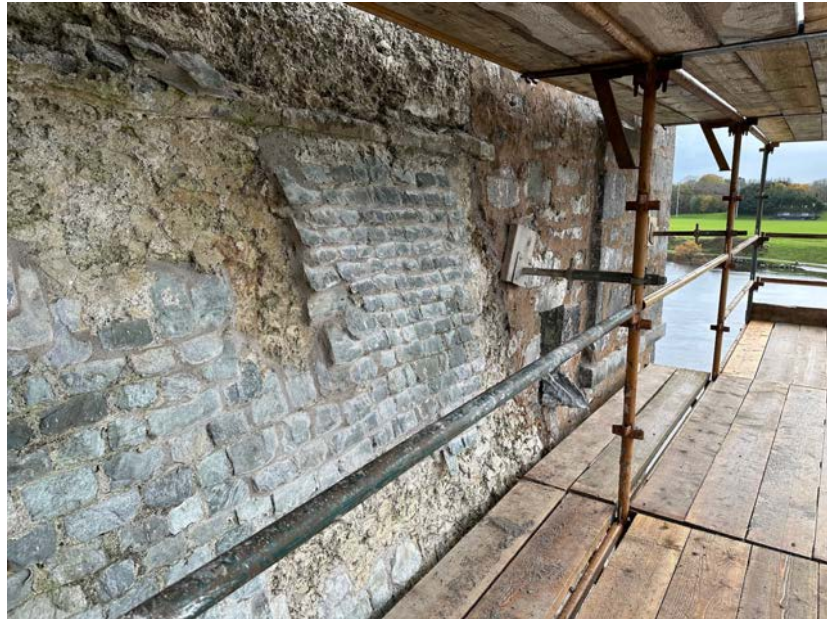
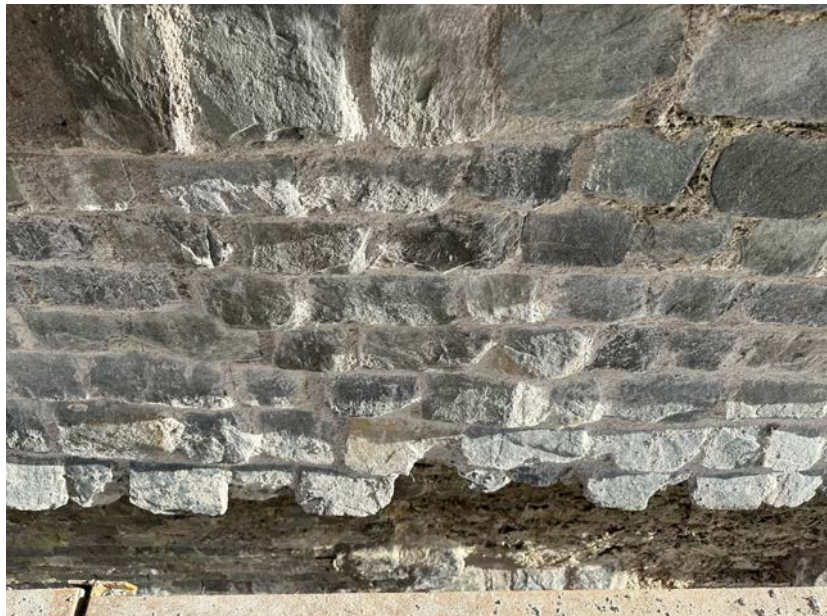
Consolidation of voids was necessary to the walls at each level, and repair of displaced or loose stone, especially around the openings. Much of the work involved the Installation of limestone lintels to

windows and fireplaces, using precast concrete lintels where required for wider spans, set between limestone lintels to exposed faces. This has made this tallest of the walls of the castle with the largest number of flues to be far more stable.

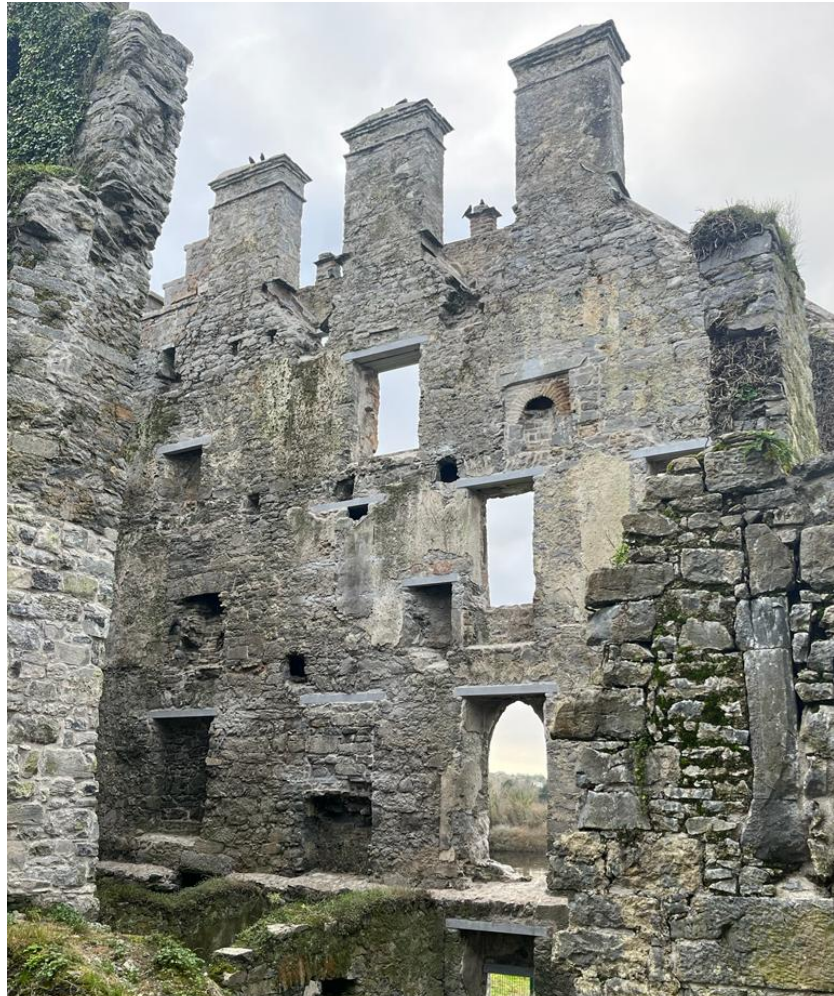
The consolidation of the slate weatherings progressed well. Slates were retrieved from the ground nearby, and along with any loose slates, were used to support the edges of surviving slates, all using lime mortar. Given the extent of loose render, there will continue to be losses over time, but there were concerns that to continue to remove loose plaster by hand would open up areas that there was no time to address.
