**FINAL REPORT ON  
ARCHAEOLOGICAL MONITORING OF  
CONSERVATION WORKS AT MENLOUGH CASTLE,  
COUNTY GALWAY**

**MINISTERIAL CONSENT C001030-  
E005312-21R0077**

**Martin Fitzpatrick  
December 2023**

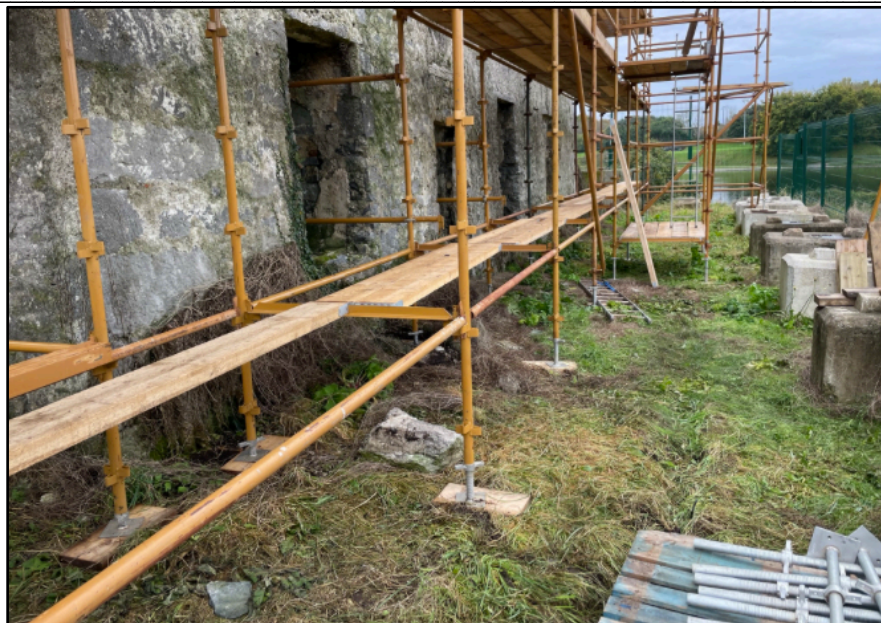
**Plate 2:** Scaffolding being erected on exterior of W wall of building.

The scaffolding on the west wall of the building was erected on the 11<sup>th</sup> of October 2023 with no interference with the existing ground level. Debris from the conservation works, accumulated at the base of the building, was removed under archaeological supervision after the scaffolding was taken down.

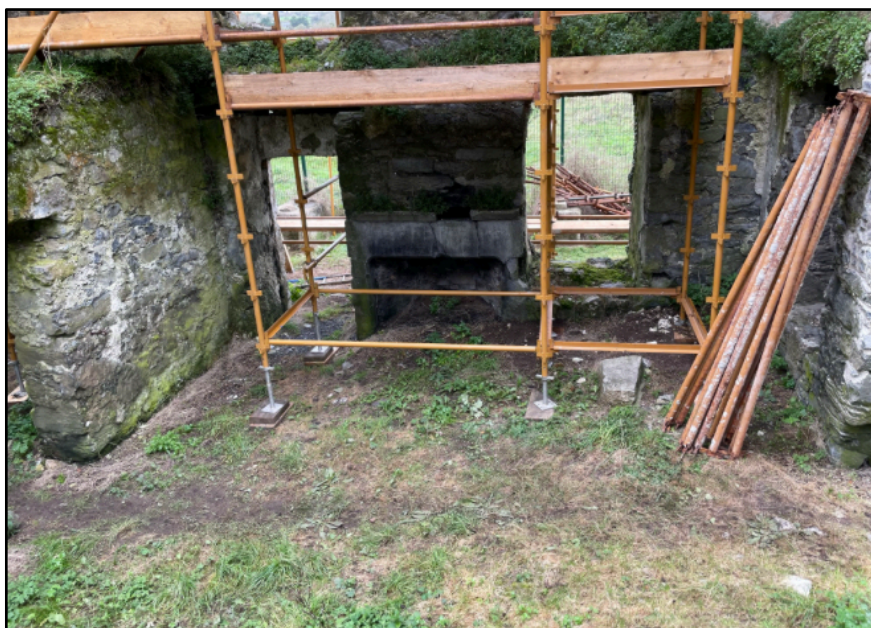
**Plate 3:** Scaffolding being erected on interior of W wall of building.

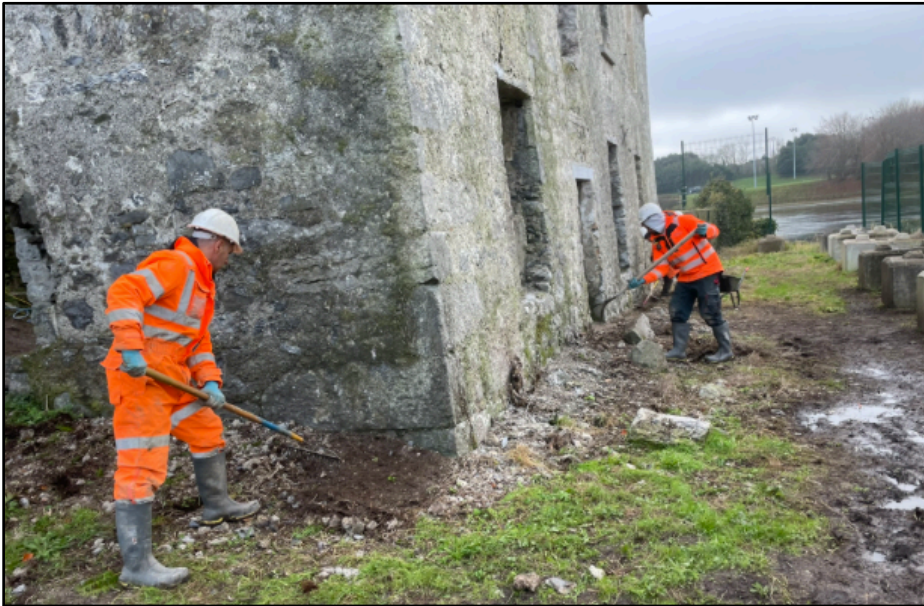
**Plate 4:** Removing debris after scaffolding removed. Taken from NW.

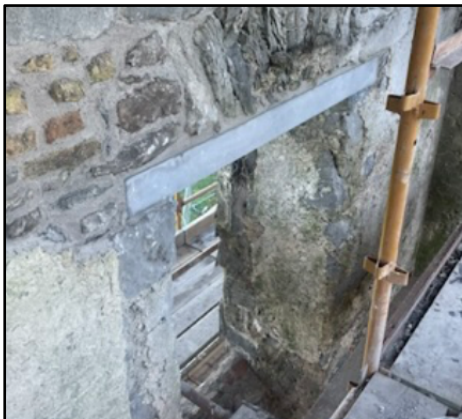
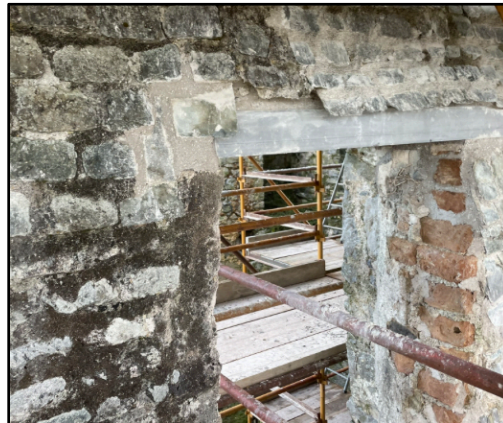
**Plates 5 & 6:** Lintels replaced and repointing above window openings.

The repairing and repointing of stonework on the internal and external face of the W wall was intermittently monitored over the course of 6 weeks. The works included the repair and repointing of fireplaces and chimneys, the insertion of new stone lintels above windows and fireplaces, repair of slates on exterior face and repair and re-pointing of joist holes.

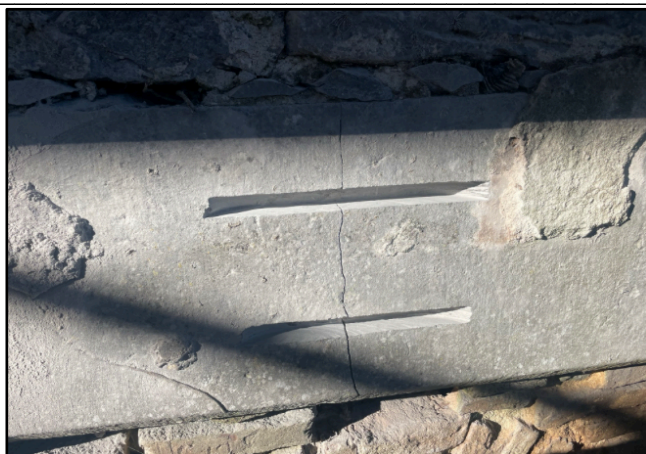
**Plate 7:** Stitching of stone to above fireplace.

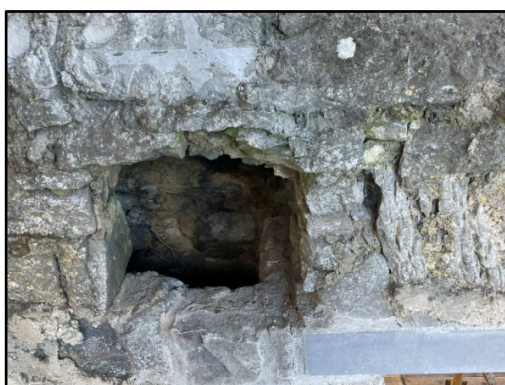
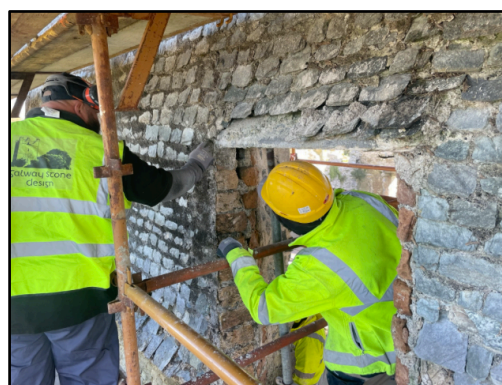
**Plates 8 & 9:** Repointing of joist hole and work on external finish on upper levels of building.

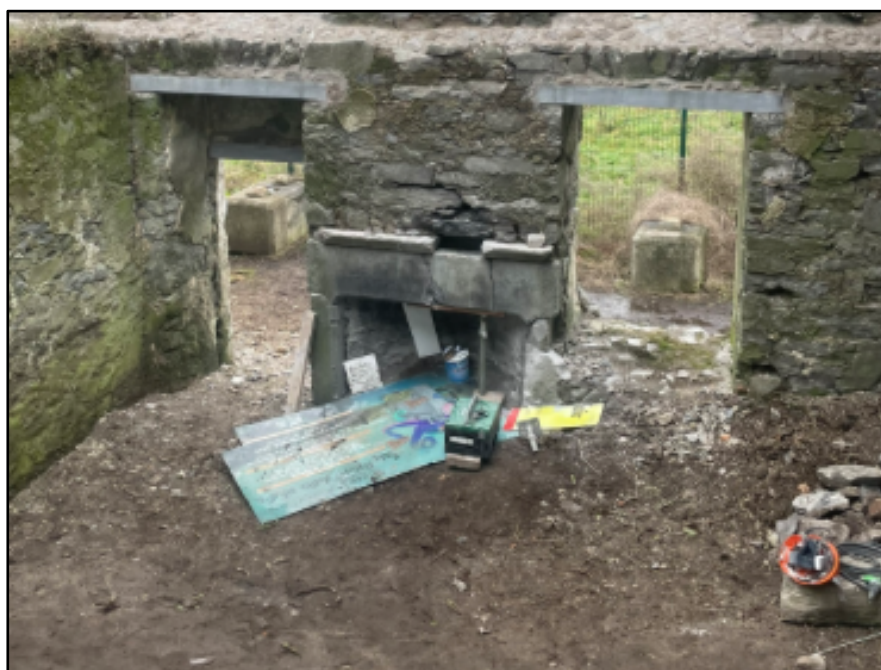
**Plate 10:** Repair works being undertaken on ground floor fireplace.

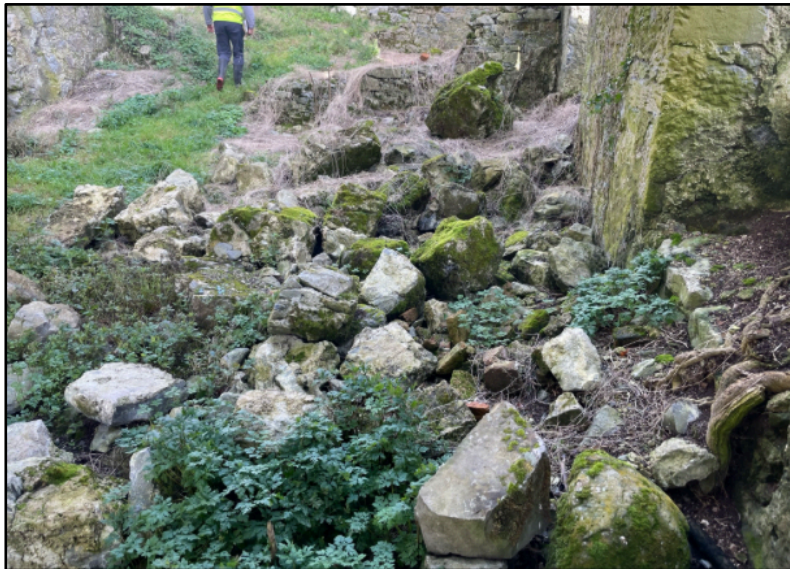
Debris from the collapse of the building after the 1911 fire has accumulated predominantly in the interior of the building with some debris on the exterior. A mini digger was used to examine the rubble piles and retrieve architectural fragments. In the SE of the interior some architectural fragments were collected from the surface and stored on wooden pallets. Extensive debris exists in the E and NE of the interior of the building and these areas were not excavated. A test pit 0.5m x 0.5m in the E of the building and 1.5m x 1m in the NE recorded rubble to a depth of c. 1m and 1.4m respectively. In the exterior of the building grass covered any architectural fragments. To avoid digging holes a trench 1.5m wide was excavated along the exterior of the building to remove the sod and topsoil layer only and retrieve architectural fragments. All of the excavations were backfilled and architectural fragments recovered are stored on pallets inside the building for re-use if required. Unworked stone was separated and stored in a separate pile while slate, brick and ridge tile fragments recovered from the site are also stored in the interior of the building and available for re-use.

**Plate 11:** Rubble in SE of interior prior to sorting of stone.

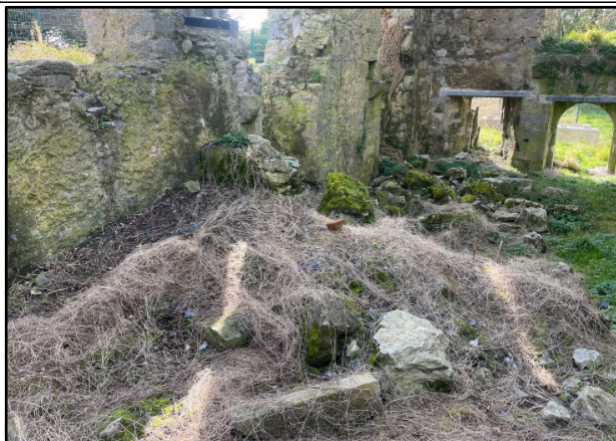
**Plate 12:** View of building rubble from NE.

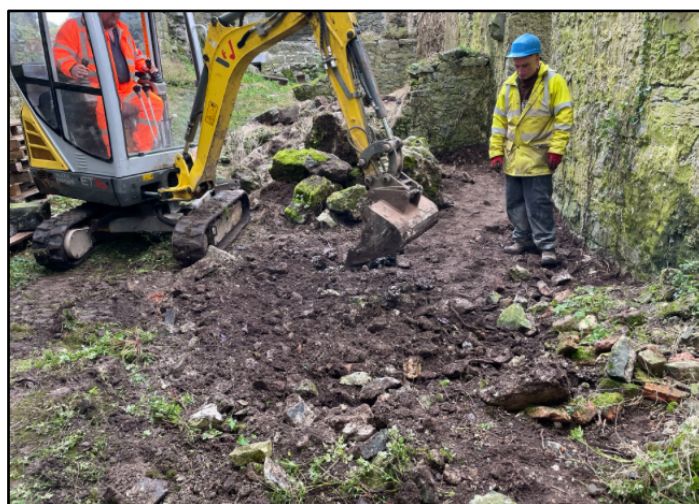
**Plate 13:** leveling of rubble in SE of site.

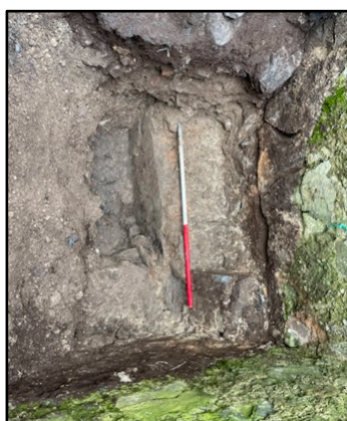
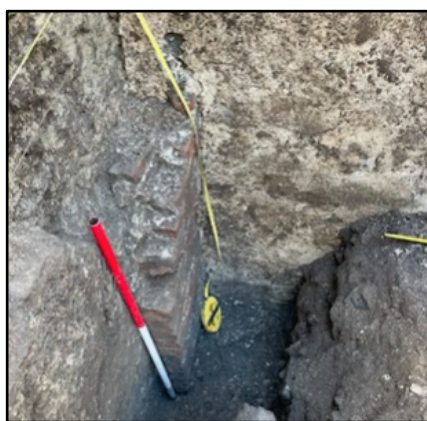
**Plates 14 & 15:** Test pit excavated in NE and E of interior.

The 2023 season works were concentrated on the west side of the building for conservation repair and repointing of features and on the east side of the building for the retrieval of architectural fragments. The works established that a depth of 1.4m-1.5m of rubble from the 1911 fire has accumulated in the N end of the building. Architectural fragments recovered from the rubble have been stored on site on wooden pallets for re-use if required.

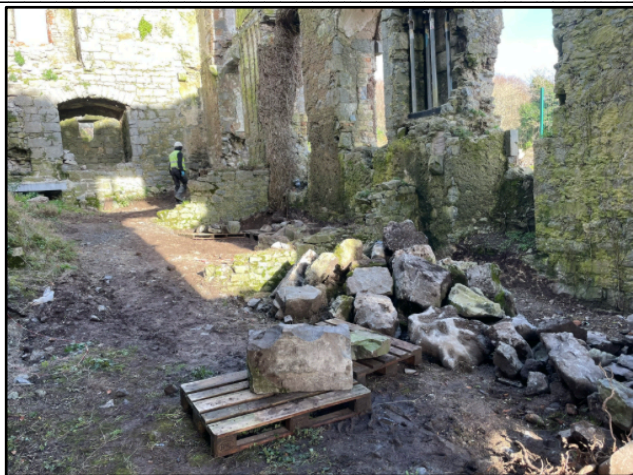
**Plate 16:** Interior of building from S after sorting stone.

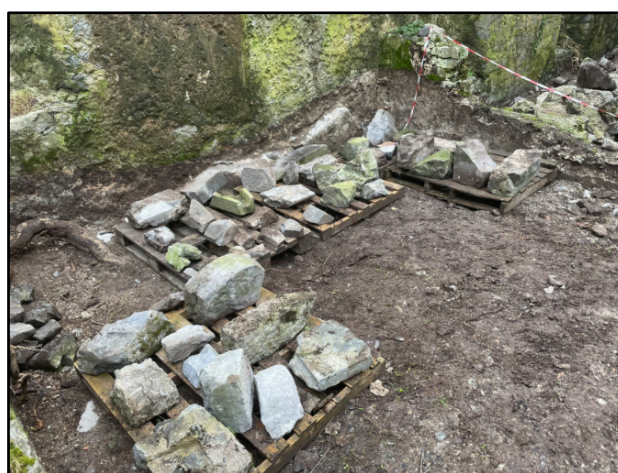
**Plate 17:** Pallets of cut stone and architectural fragments stored on site.

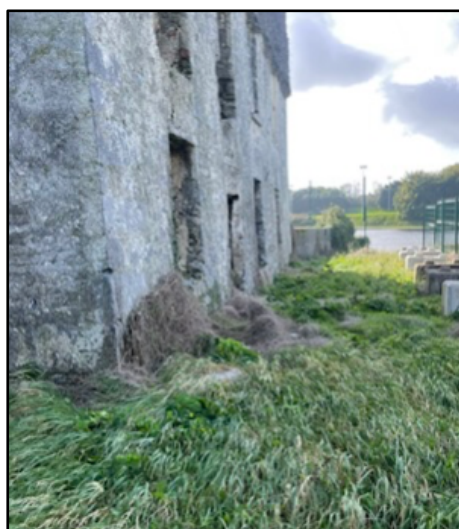
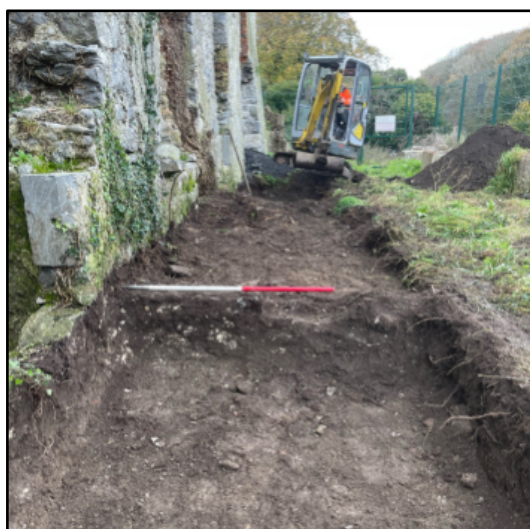
**Plates 18 & 19:** Exterior of E side of building from the S and during works to retrieve architectural fragments.

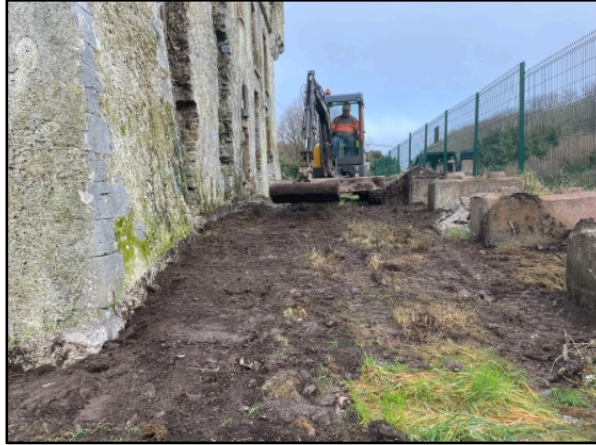
**Plate 20:** Exterior of building from S after removing architectural fragments and backfilling.
