MENLOUGH CASTLE
GALWAY CITY

CMF23-1-GC001

Final Report

NOVEMBER 2023

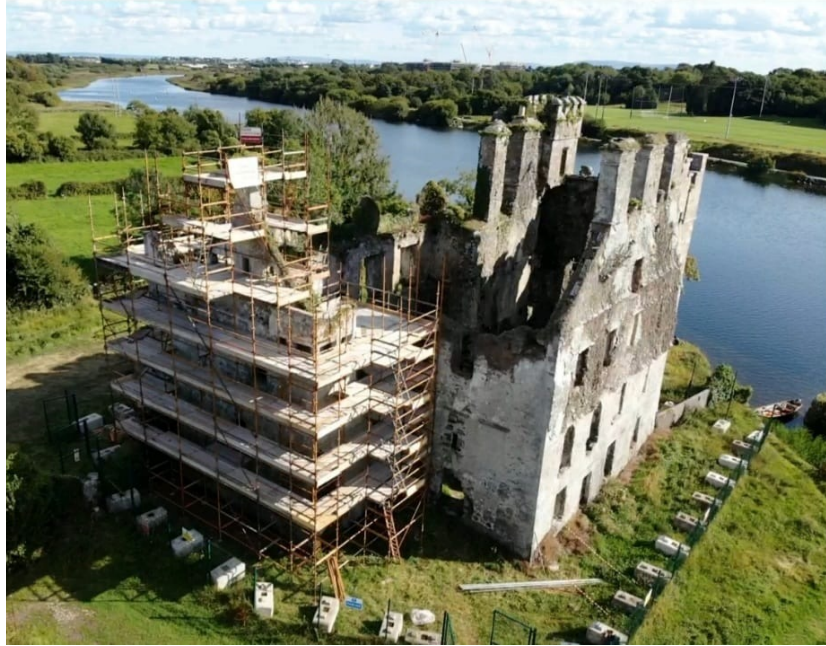
The castle has suffered regular instances of vandalism including deliberate disturbance of the wildlife. Having lost its roof and floors, and due to gradual rotting out of lintels, the castle is in a concerning state. Its walls, while still standing tall for the most part, are at risk of complete collapse, aside from occasional loss of stone from its openings and tops which put visitors at risk of injury. Heaps of stone and debris from earlier collapses are likely to survive underfoot as the ground is very uneven internally.
